Navajo Abandoned Uranium Mine

Site Screen Report

NA-0919B AUM Site

August 2010

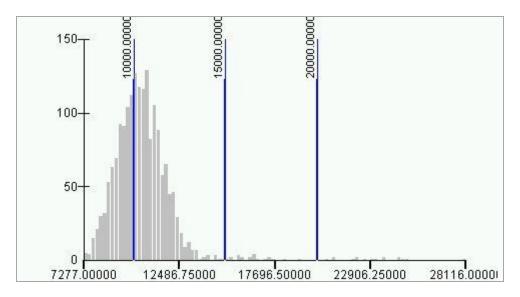
The following chart and statistics were generated by ESRI ArcGIS 9.3.1, and show the general distribution of the site gamma radiation measurements. The horizontal X axis represents the gamma radiation reading levels in cpm (lowest levels to the left). The vertical Y axis represents the frequency of each gamma radiation level.

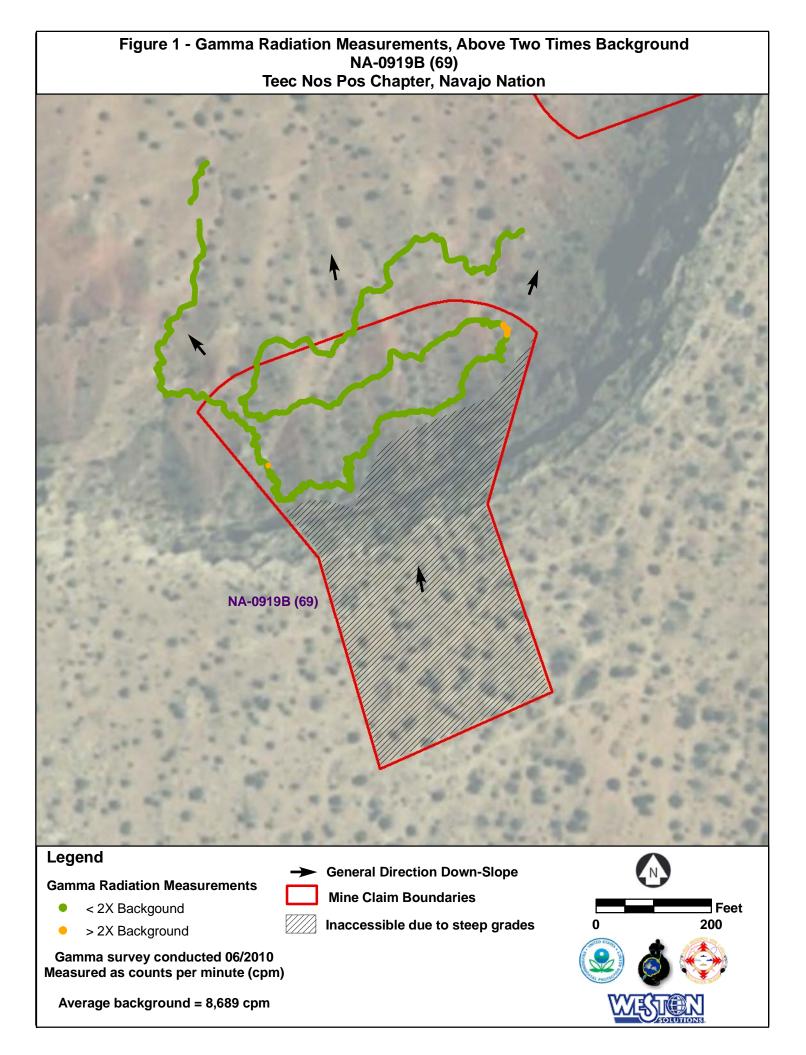
Figure 2 - Gamma Radiation Measurements NA-0919B (69) Teec Nos Pos Chapter, Navajo Nation

A total of 1,799 gamma radiation measurements were collected from the mine site, ranging from 7,277 cpm to 28,116 cpm. The measurements are represented in Figures 1 and 2.

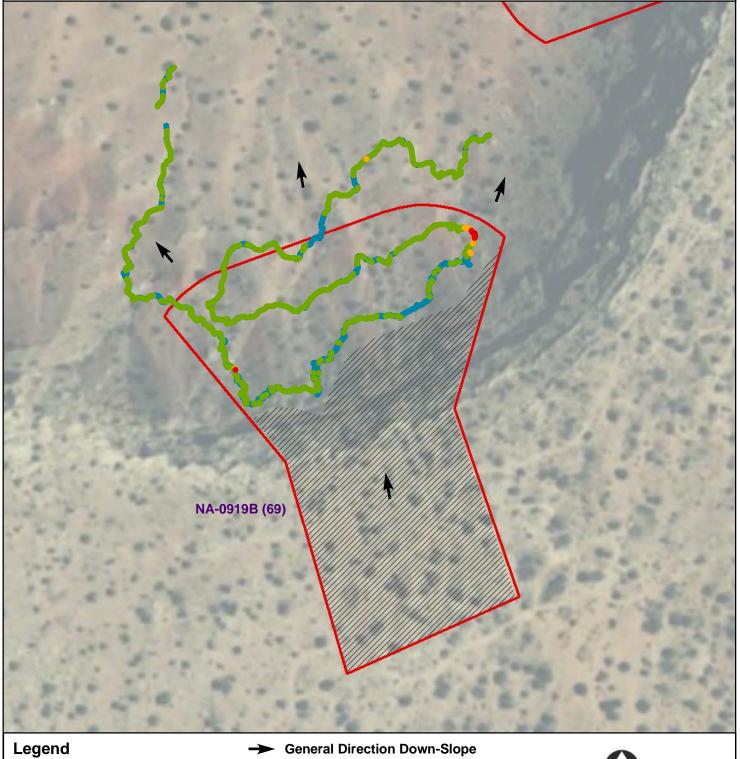
28,116 counts per minute (cpm)

Average background = 8,689 cpm
